DEPARTMENT OF TRANSPORTATION

Quality Assurance and Source Inspection

Contract #: 04-0120F4Cty: SF/ALA Rte: 80 PM: 13.2/13.9File #: 69.28**WELDING INSPECTION REPORT****Resident Engineer:**Pursell, Gary**Address:** 333 Burma Road**City:** Oakland, CA 94607**Report No:** WIR-014400**Date Inspected:** 22-May-2010**Project Name:** SAS Superstructure**OSM Arrival Time:** 700**Prime Contractor:** American Bridge/Fluor Enterprises, a JV**OSM Departure Time:** 1900**Contractor:** Zhenhua Port Machinery Company, Ltd (ZPMC), Changxing Island **Location:** Shanghai,China

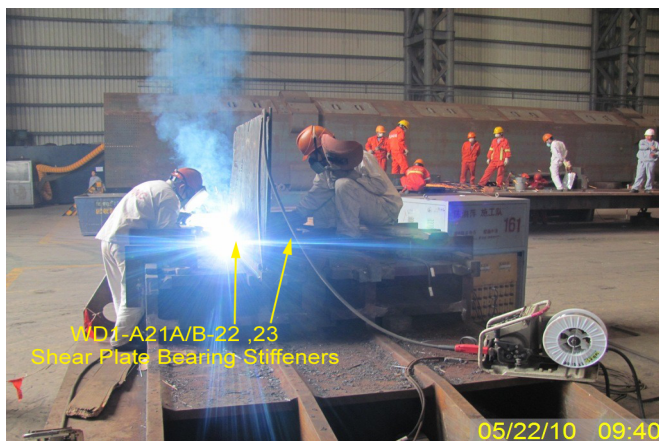
FCAW welding of weld joint no: WD1-A21A/B-22 located on Shear Plate Bearing Stiffener. Welder is identified as 040609.ZPMC QC is identified as Mr.Xu Jie. The welding variables recorded by QC appeared to comply with the WPS-B-T-2331-TC-P4-F.Please see the attached picture.
